SUBSTATION STABILIZATION

EASTERN VIRGINIA

INITIAL CONCERN

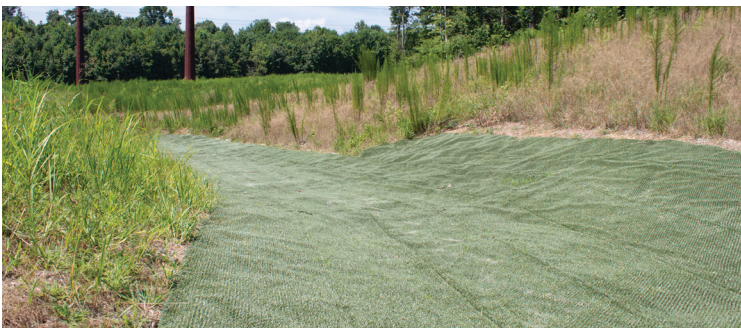
Before hurricane—outfall channel.

All three applications were outfitted with ShearForce 10. The installation process was simple with the ground ALREADY prepared and seeded prior to the installation of the mats. When the prep work was complete, the mats were simply unrolled and pinned into place with anchor trenches dug upstream to prevent uprooting of the matting. 12-in pins with washers were used to anchor the mats down, and 6-in U staples were used to hold the mats together along the seams.

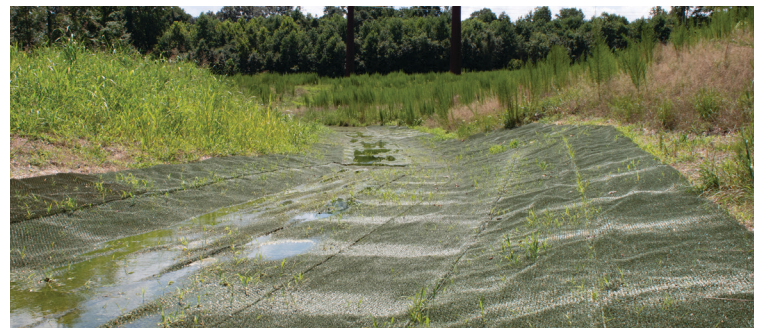
After hurricane—outfall channel.

While the owner was thrilled with the results following installation, the installation and term “immediate protection” was put to the test almost 2 weeks later when Hurricane Isaias came through, dumping 6” of rainfall on the site with wind gusts of 50+ mph. This storm would have devastated the existing sod or a newly installed TRM. As the pictures above and on the back show, the newly installed ShearForce successfully protected all areas from erosion and was not affected by the storm. After experiencing this success, the owner is now installing this product on other sites as well.

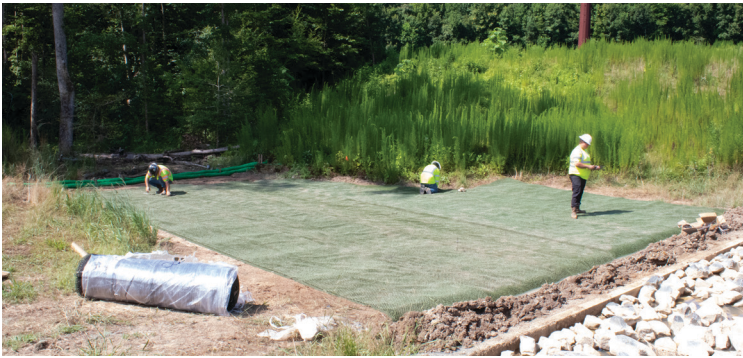
Before hurricane—emergency spillway.

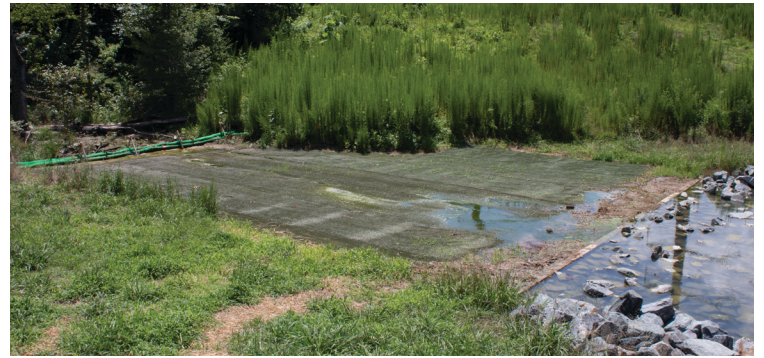
After hurricane—emergency spillway.

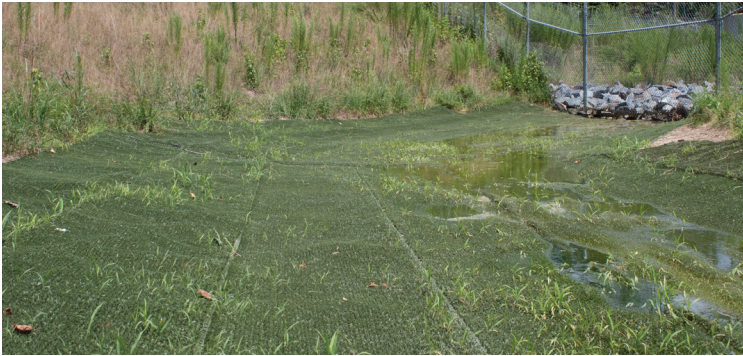
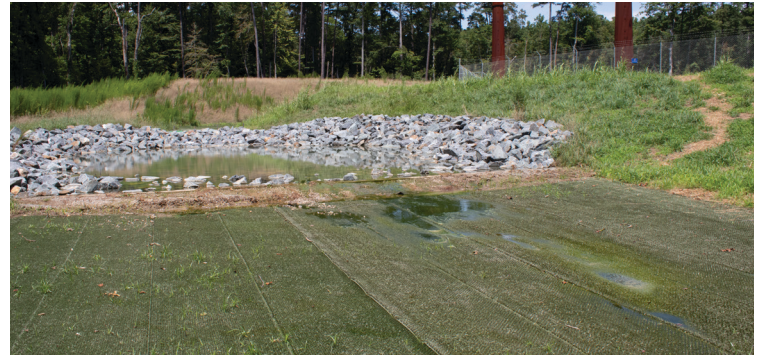
Additional photos after Hurricane Isaias.

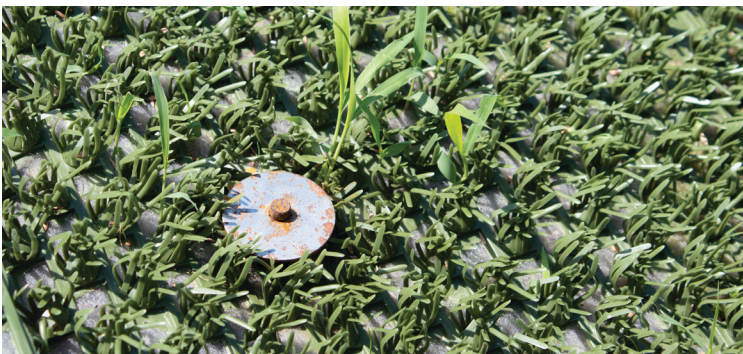
Anchored using pins and washers.

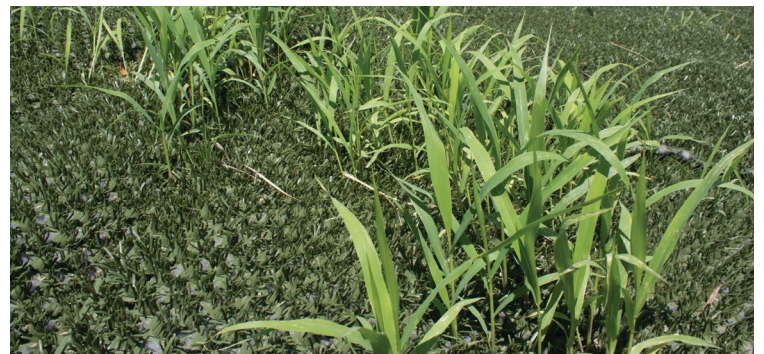
Vegetation growth 3 weeks after installation.
