REPLACEMENT OF FAILED CONCRETE STORMWATER STORAGE SYSTEM

HARRISON, NY

INITIAL CONCERN

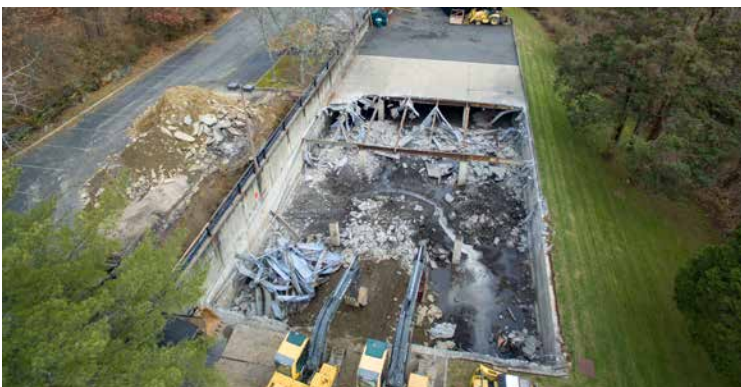
The top slab of an existing underground concrete stormwater storage system was severely cracked and failing. The cracked system was located underneath an existing office complex parking lot, which created potentially hazardous conditions for those who parked there. Failing concrete systems create conditions for sinkholes to develop.

Prior to installation

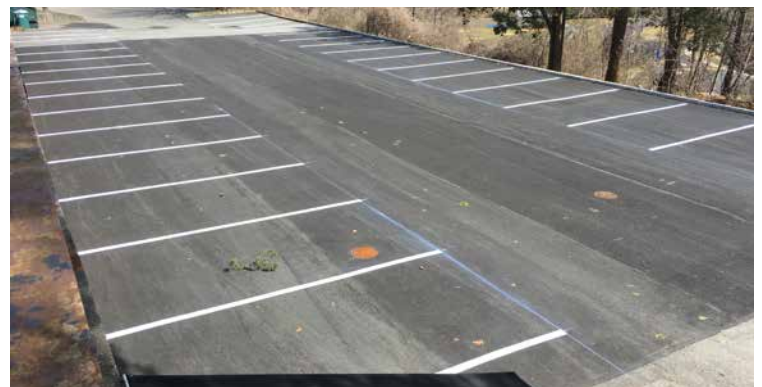
Post-installation

R-Tank HD Pent 7-ft modules were selected to replace the existing system due to the high void space and cover parameters. To allow for the passage of water from the tanks to the perimeter stone, the system was wrapped in SR-18 microgrid. Additionally, TrashGuards were placed in the upstream drains feeding into the system for collection of sediment, trash and debris.

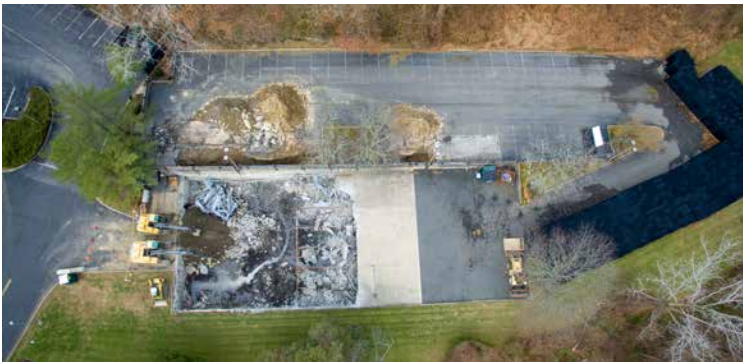
Demolition of the failing concrete stormwater storage system.

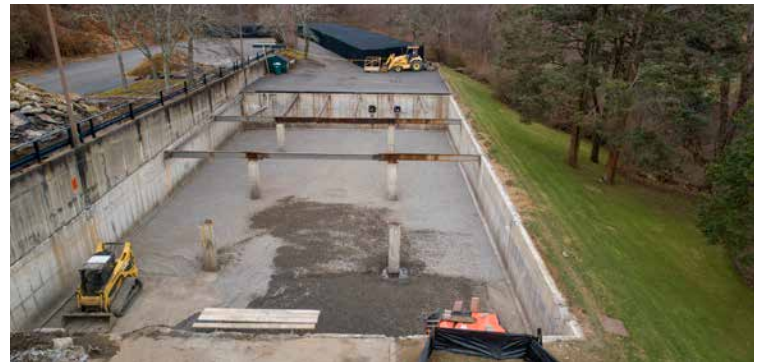
Base prep for the installation of the system.

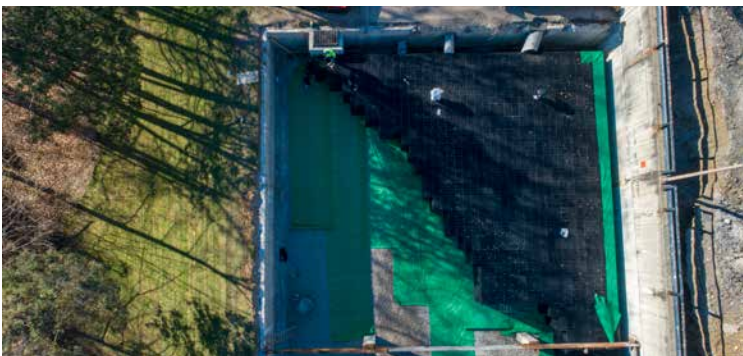
R-Tank HD Pent 7-ft modules filled the existing concrete footprint.

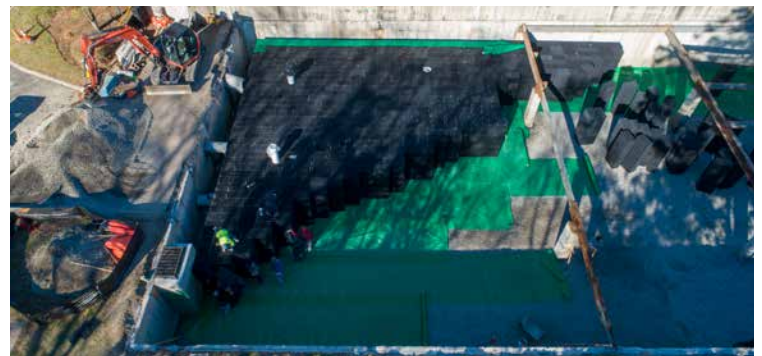
The system was wrapped in SR-18 microgrid (pictured in green).

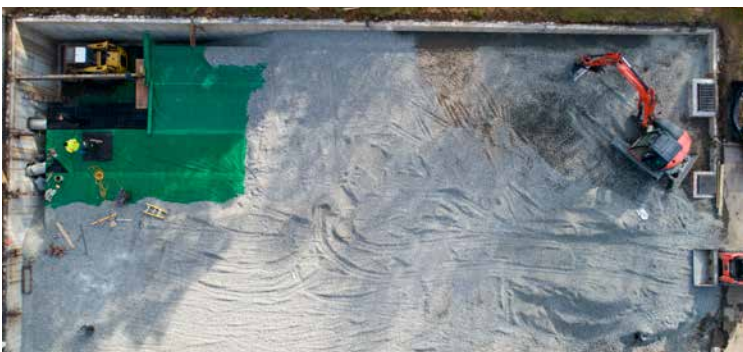
Crushed stone cover layer placed over the tanks and SR-18 microgrid prior to final layers.
