SCOURLOK® RETENTION WALL

HORNELL, NY

INITIAL CONCERN

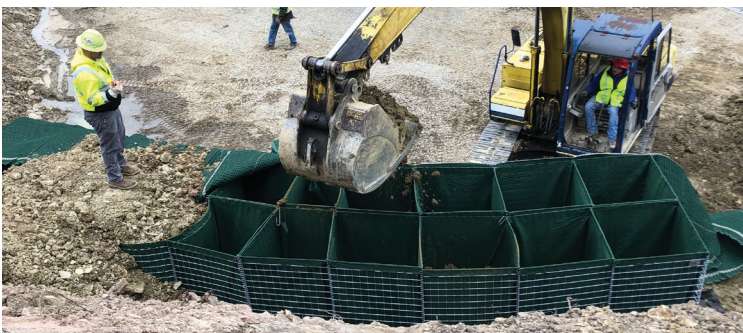
First layer of Scourlok being filled - 2 cells deep.

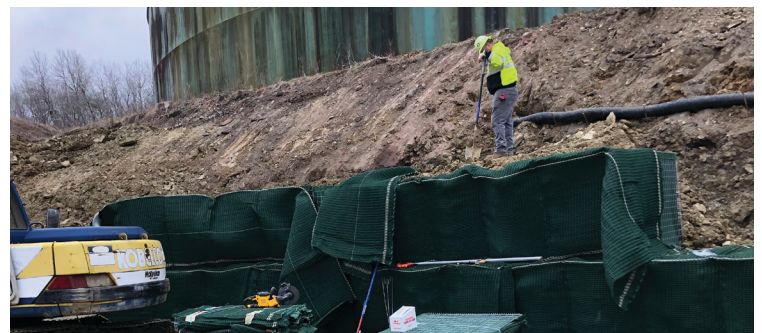
Second layer of Scourlok being covered with soil following being filled (1 cell deep).

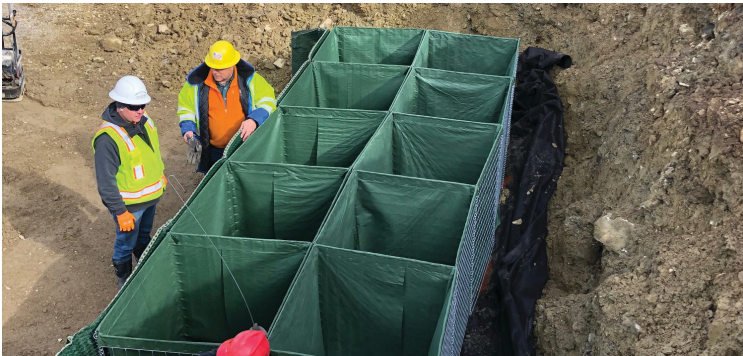
Connecting the cells for the first layer of Scourlok.

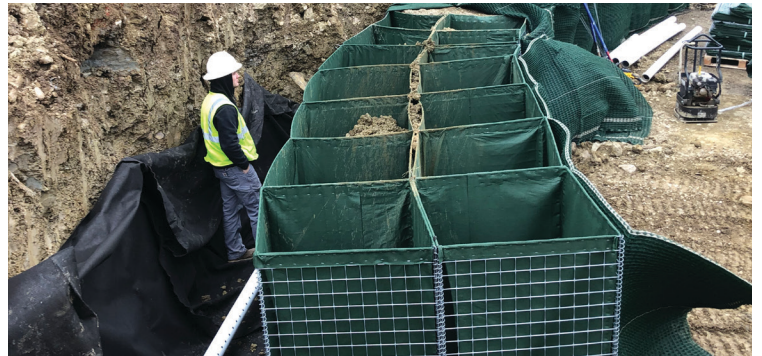
Scourlok flexibility to work with radial alignment.

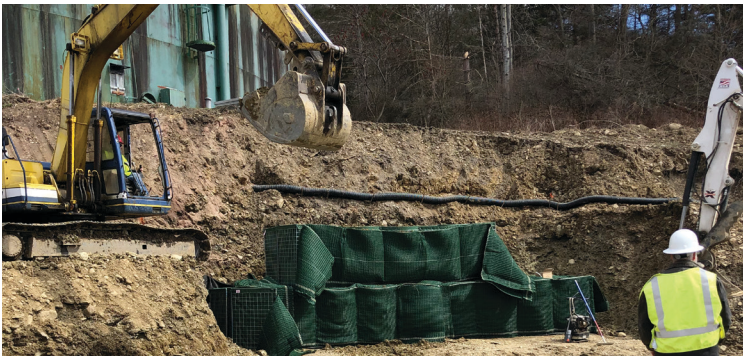
Machinery filling cells with on-site material.

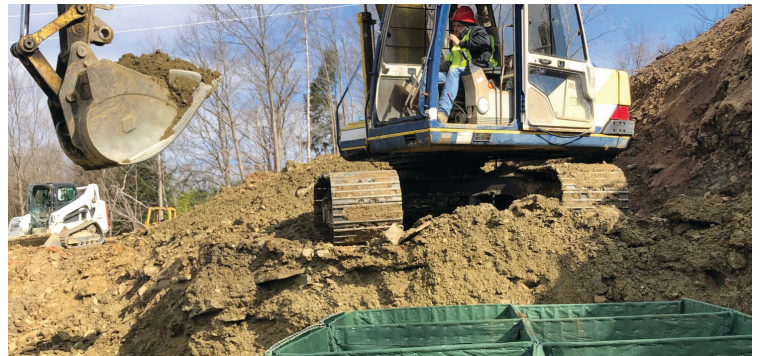
Limited space on site for installation.

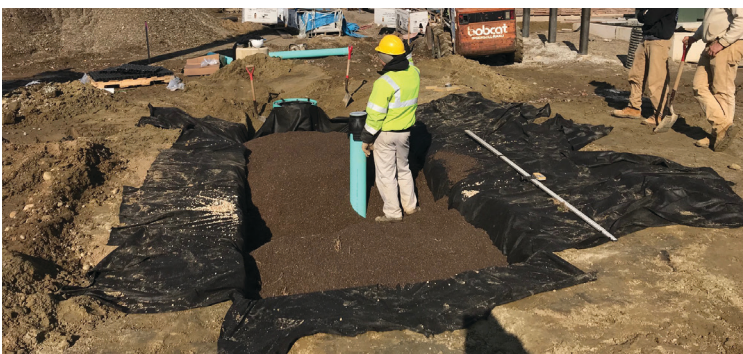
Access created for water tank installation.

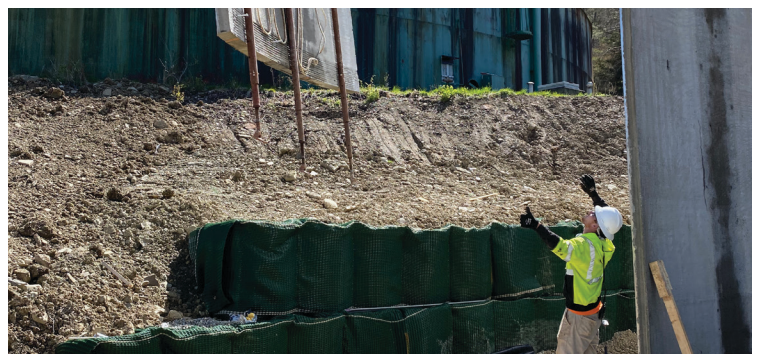
Placing of water tank panels near Scourlok face.
